# KRAKsat Satellite Mission – Lessons Learned [EN]

Technical Report · December 2019

# KRAKsat Lessons Learned

December 10, 2019

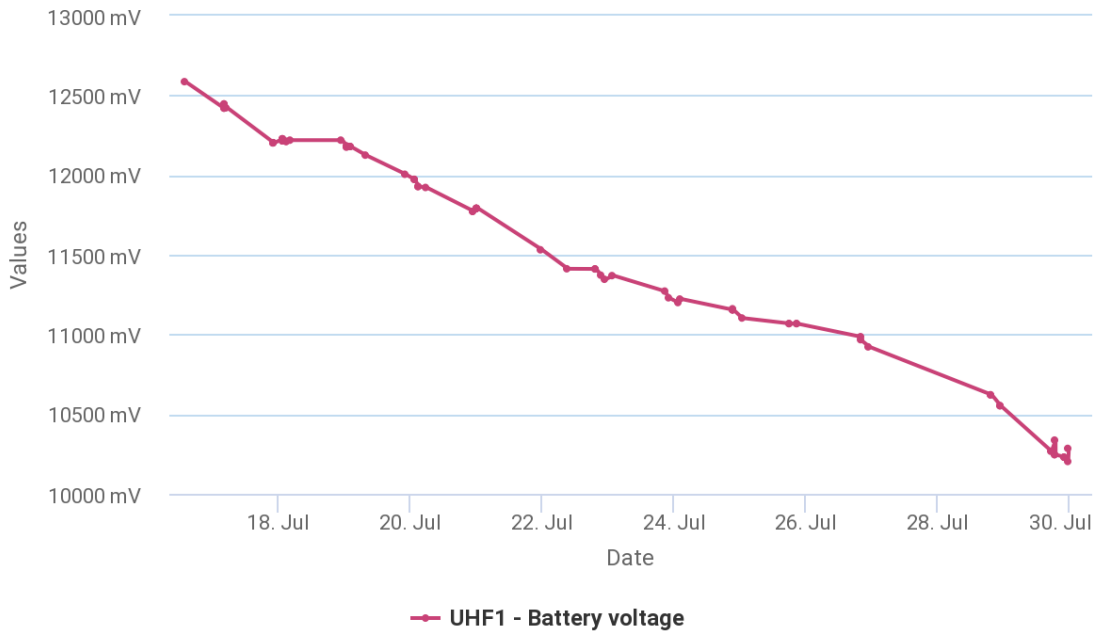
Figure 6: KRAKsat satellite power graph

In the second phase of the mission, the satellite's power supply system had a negative energy budget. On-board

devices used more energy than solar panels were able to provide. The attempt to completely turn off the device did not increase the battery voltage, keeping it on a similar or even lower level. Despite stable communication having been achieved, goals of the mission could not be fulfilled. Crucial errors found during the operation of the satellite prevented execution of the Ferrofluid Reaction Wheel experiment.

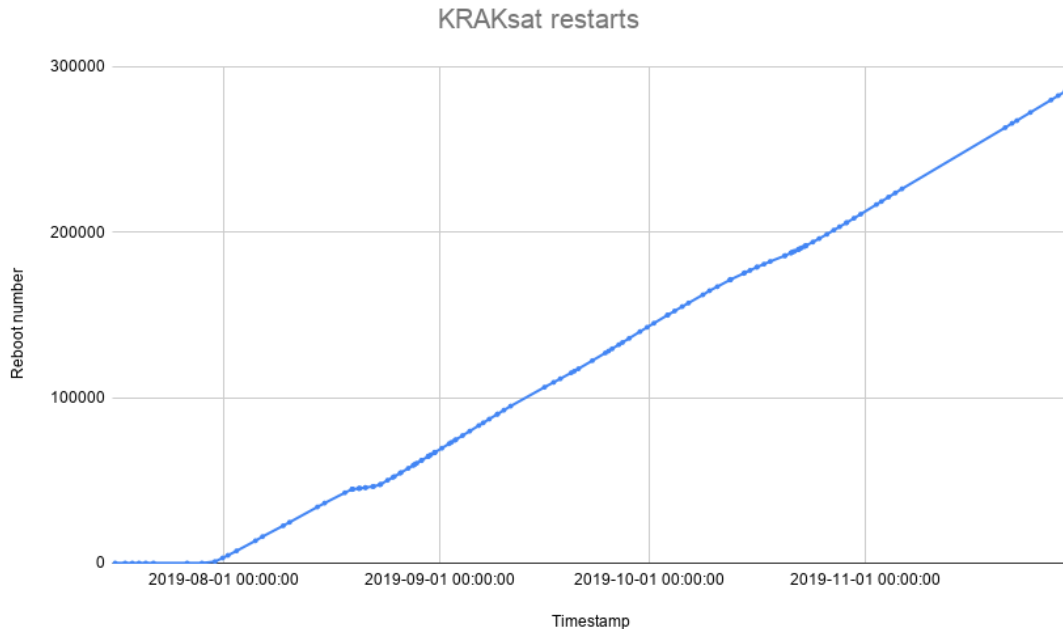
Figure 7: KRAKsat satellite reboots graph

On the 30th of July 2019, KRAKsat’s power dropped to its limit value, causing all systems to shut down. Due to the lack of hysteresis implementation, turning off the device resulted in lifting voltage values, which then led to another restart of the satellite. Each time the KRAKsat is turned on, it should transmit information about radio activation, the reboot number and all status frames in the form of a beacon. Attempting such a transmission overloaded the devices EPS, causing the satellite to turn off, and several seconds later, when the voltage increased slightly, another start-up. The third phase restart loop was characterized by a relatively constant frequency of about 150 reboots on one orbit around the Earth. Between reboots of the UHF1 and the UHF2 radios, a very short time window took place in which it was possible to communicate with the satellite.

According to the data collected during the third phase of the mission, the KRAKsat probably only restarted in the sunlight - remaining turned off in the shadow. The restart loop was caused directly by the power dropping below the limit value and the lack of implementation of the hysteresis, which should have allowed the battery to charge to the level at which the satellite could work properly. Many time windows gave chances of communication with the satellite of which, few were used. The mission control team was able to shift the frequency of the KRAKsat broadcast by 2kHz to reduce jamming with the Światowid satellite signal (operating in the same range of frequency), as well as receive a frame with information about the power supply

A well-designed EPS should have a hysteresis loop implemented. The voltage level switching on the satellite should be significantly higher than the level switching it off. The missing hysteresis implementation caused an endless loop of satellite restarts when its voltage dropped below 9.5 V.

This critical error caused an irreversible blockage of the satellite in the restart loop. It became the key reason for the inoperability of the satellite after entering the third phase of the mission.

There should be a hysteresis system implemented in the EPS. Voltage levels should be selected in a way that the switch-off level would protect the battery against damage, and the switch-on level would allow the satellite to function at least until the next communication session.
