# KRAKsat Satellite Mission – Lessons Learned [EN]

Technical Report · December 2019

# KRAKsat Lessons Learned

December 10, 2019

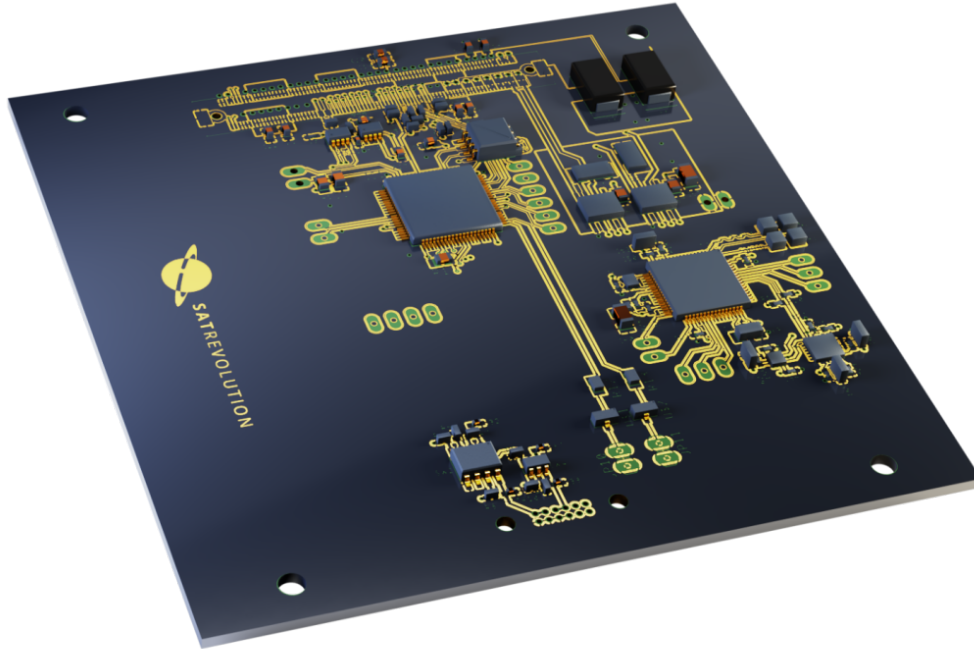
Figure 3: OBC [photo by SatRevolution]

The error was identified during the mission and it took several days of communication sessions to find the solution. Correct data storage has been proved to be possible through the usage of other commands that allow more advanced flash memory handling. A lot of time had been wasted by this mistake, which, combined with the falling voltage, meant that the satellite operators failed to obtain any valid data from the experiment.

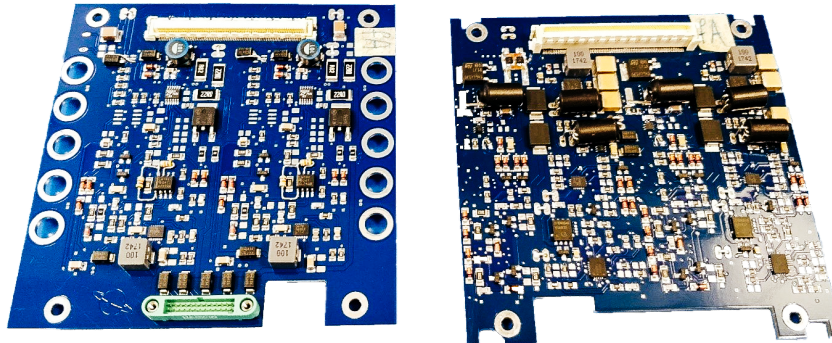
Figure 4: EPS [photo by SatRevolution]

Since the launch of the satellite on the 16th of July, the voltage level on the batteries has been constantly dropping. Due to the insufficient data received from KRAKsat, the mission control team was unable to determine the root cause of the problem. Precisely calculated energy budget and pre-flight tests of integrated systems in the simulated orbital environment could prevent discharge or locate the possible cause to eliminate it in advance.

A well-designed EPS should have a hysteresis loop implemented. The voltage level switching on the satellite should be significantly higher than the level switching it off. The missing hysteresis implementation caused an endless loop of satellite restarts when its voltage dropped below 9.5 V.

This critical error caused an irreversible blockage of the satellite in the restart loop. It became the key reason for the inoperability of the satellite after entering the third phase of the mission.

When designing a satellite, the largest possible safety reserve should be included in the energy budget. Such an approach would guarantee a positive energy balance on the orbit. Accurate tests must be carried out on the integrated device to check probable battery consumption by individual components in different lighting conditions.

There should be a hysteresis system implemented in the EPS. Voltage levels should be selected in a way that the switch-off level would protect the battery against damage, and the switch-on level would allow the satellite to function at least until the next communication session.

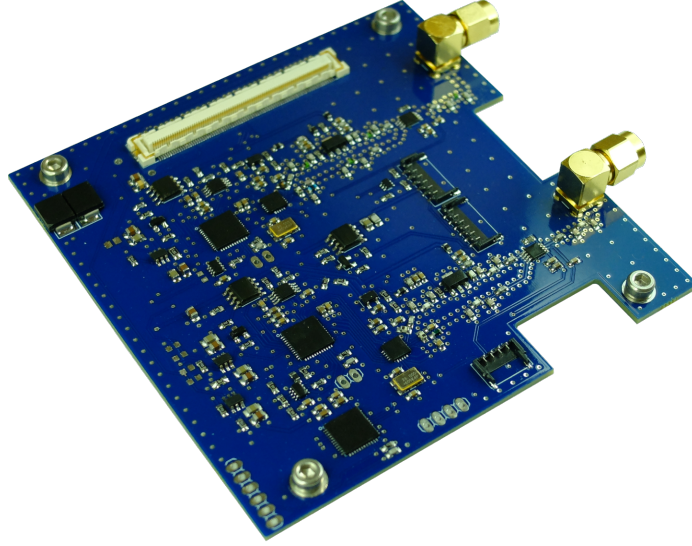
Figure 5: Communication Module [photo by SatRevolution]

On the 19th of August, a temporary failure of the UHF1 radio module has occurred. The satellite still remained in the restart loop, but it had enough energy to attempt to transmit several beacon frames. The fourth mission phase lasted until the 23rd of August.

On the 23rd of August, the UHF1 radio started to function properly again by itself. The energy consumption of the satellite increased to the state before the radio failure, and remained stable in terms of restart frequency (150 reboots every 90 min). The loop lasted until the 12th of October. From the 12th of October the frequency of restarts began to drop irregularly. Residual data could not determine the exact progressive pattern changes, however, it seemed to be non-deterministic. The lower frequency of restarts has continued until around the 24th of October, which then return to the previous typical values.
